Manhole Inspection Summary

Manhole # S45KK_031MH

Insp Date: **4/2/08 1:08 PM**

Location Address: **Castle St**

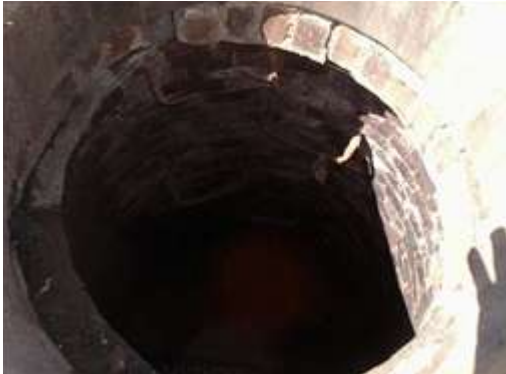
Defect 1

Condition: ☐ Sound ☐ Cracked ☐ Root Intrusion ☒ **Loose Brick** ☐ Deteriorated

loose bricks

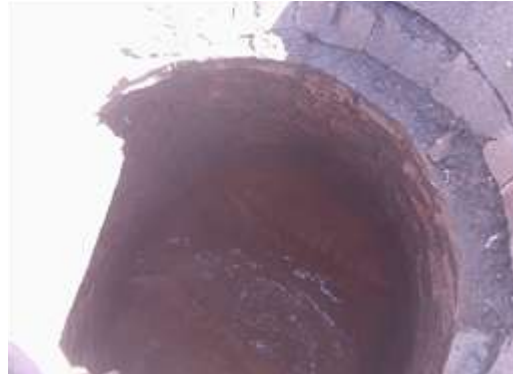
Defect 2

☒ **Leaks**

frame leaks

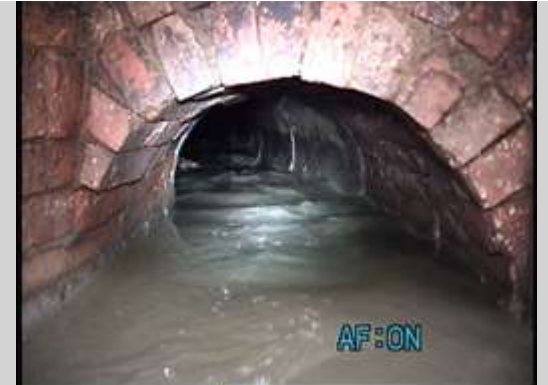
12 O'Clock Outflow

15 in. Circular Gravity Sewer
Pipe Out @ 12 O'Clock

Pipe Height: **15.6** (in.) Rod and Bar (Angled)
Pipe Material: **Clay** ☐ Pipe Lined
Invert Depth: **10.00** (ft.) Flow Characteristics: **Fast**
Deposits: ☐ None ☐ Mud ☒ Sludge ☒ Debris ☐ Grease
Silt Depth: **3** (in.) Deposits Extent: **Medium**
Infiltration: **None** Pipe Seal Cond: **Sound**

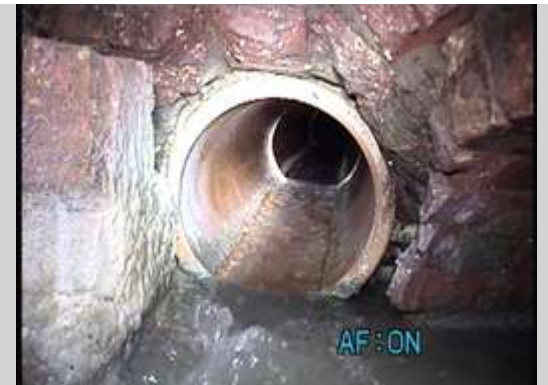
5 O'Clock Inflow

8 in. Circular Gravity Sewer
Pipe In @ 5 O'Clock

Pipe Height: **8.4** (in.) Rod and Bar (Angled)
Pipe Material: **Clay** ☐ Pipe Lined
Invert Depth: **9.80** (ft.) Flow Characteristics: **Fast**
Deposits: ☒ None ☐ Mud ☐ Sludge ☐ Debris ☐ Grease
Silt Depth: (in.) Deposits Extent:
Infiltration: **None** Pipe Seal Cond: **Sound**

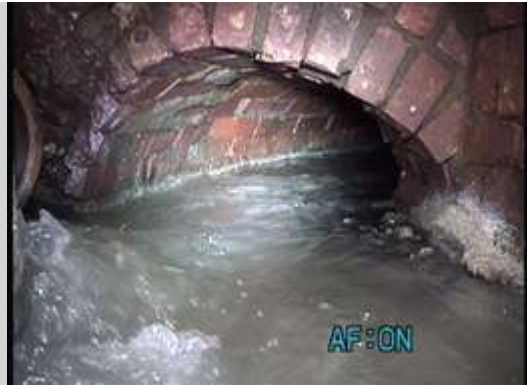
7 O'Clock Inflow

15 in. Circular Gravity Sewer
Pipe In @ 7 O'Clock

Pipe Height: **15.6** (in.) Rod and Bar (Angled)

Deposits: ☒ None ☐ Mud ☐ Sludge ☐ Debris ☐ Grease

Infiltration: **None** Pipe Seal Cond: **Sound**
